Client Report No 12072101

Client: Meika Kapa - Bay of Plenty Regional Council

Project: Effectiveness of floating ramp fitted with mussel-rope for facilitating fish access into a perched culvert.

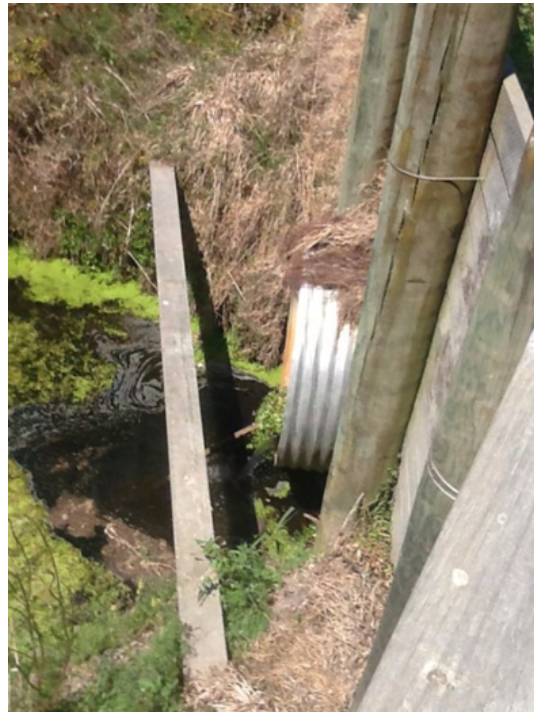
Figure 1 - Outlet (December 2019)

This is a private culvert on a tributary of the lower Rangitaiki River. The culvert is located approximately 12 km from the coast, with a diameter of 800mm, and is perched by 800mm with an undercut of 480mm. The culvert was identified as likely causing a barrier to fish migration. (Figure 1.).

Flow exited the culvert into a deep plunge-pool, presenting with significant scouring of the bed material.

The culvert barrel had no bed material, indicating that it was possibly a velocity barrier.

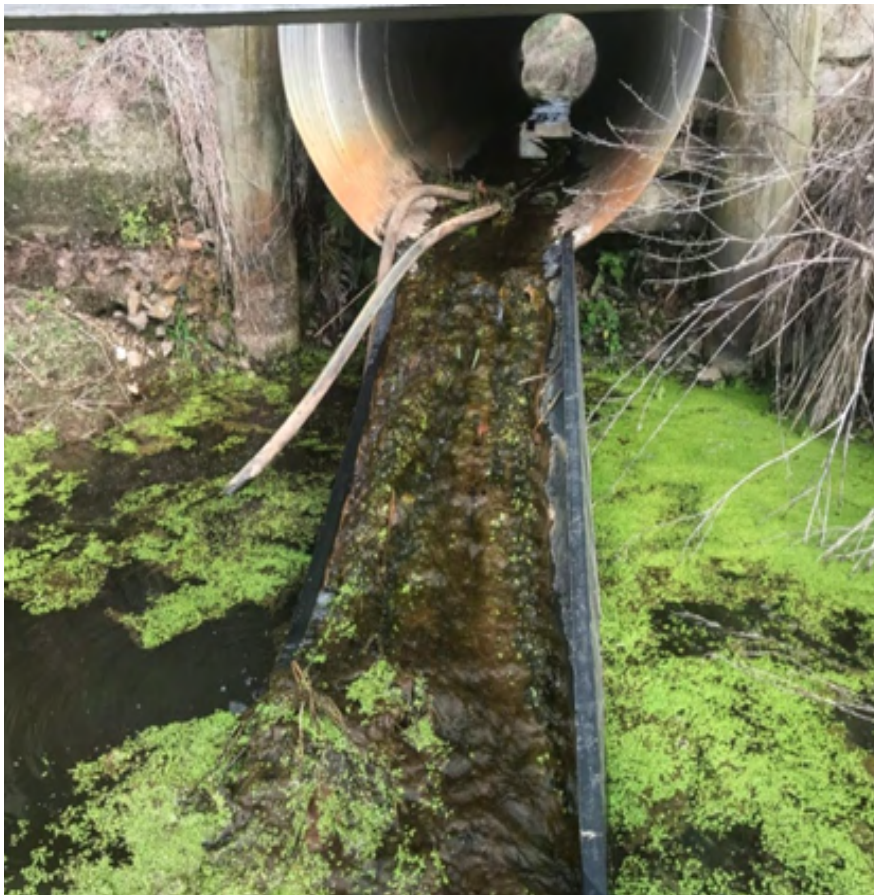
Figure 2 - Outlet (March 2020)

The mussel-rope passes over a 100mm high flexible v-baffle with 45° cut ends, fitted 300mm up from the outlet of the culvert (Figure 2).

A 2.4-meter floating ramp (ATS-Environmental) at approximately 30° gradient at time of installation.

The ramp was attached to the culvert with a flexible rubber coupling.

The ramp has a 15° “V” and a smooth surface i.e. not Miradrain® dimples as featured in the NZ Fish Passage Guidelines.

8 lengths of mussel-rope were fitted down the ramp in 2 bundles of 4 strands instead of using Miradrain®.

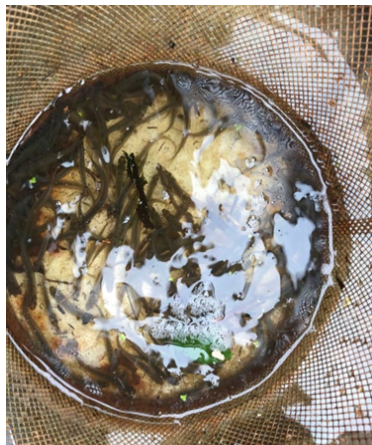
Figure 3 - Fish captured upstream - December 10th 2019

After remediation, a total of 4 fish (1 common bully, 3 inanga) were captured downstream, while 125 fish were captured upstream of the culvert (3 common bully, 1 short-fin eel, 121 inanga) (Figure 3.).

The high numbers of inanga captured upstream of the culvert suggests the ramp worked well for this species. Too few common bullies were captured to determine if the ramp was effective for this species. As Gee Minnow traps do not target eels, no information on passage was gained for shortfin eels.
