Fish-Passage Field Findings

June 2020

Lessons Learnt 02: Flexi-Baffle installation to restore fish passage in a long, complex culvert

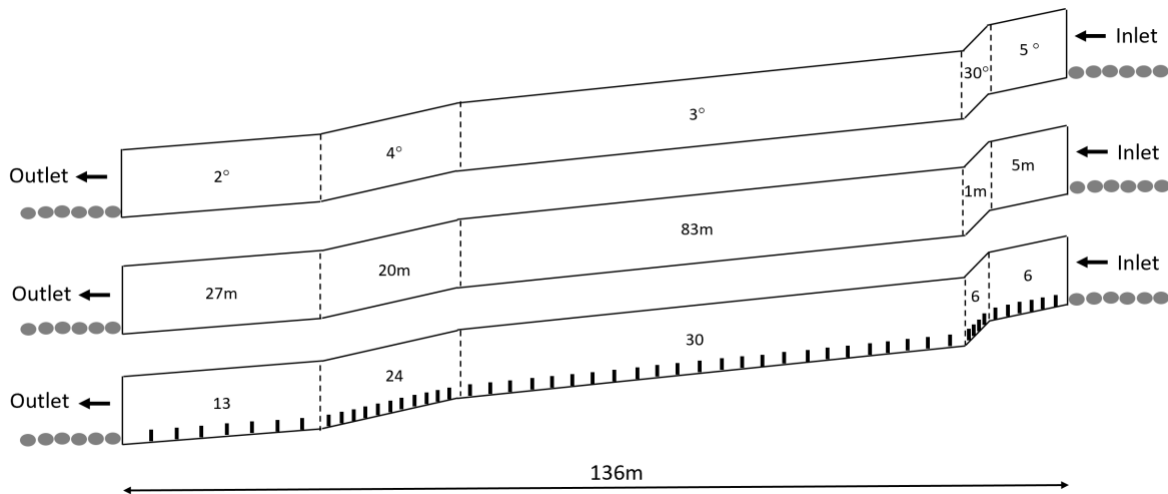
Reservoir Creek is a small, coastal stream that runs through urban Nelson. Approx. 1.5 km inland from the coast at an elevation of 31 m, the stream is piped through a complex culvert system. The culvert is 1.6 m diameter, 136 m long and has variable gradients ranging from 2° to 30° (Figure 1). The culvert is made up of different materials (concrete and metal) and changes direction numerous times. Fifteen previous fish records show that longfin and shortfin eels (*Anguilla dieffenbachii* and *A. australis*), banded kokopu (*Galaxias fasciatus*), koaro (*Galaxias brevipinnis*) and common bully (*Gobiomorphus cotidianus*) were found upstream and downstream of the culvert, while Inanga (*Galaxias maculatus*), and redfin bully (*Gobiomorphus huttoni*) were only found downstream (source NZ Freshwater Fish Database). It should be noted that there is only one record of common bully upstream of the culvert.

Figure 1. Cross section of Reservoir Creek culvert showing changes in gradient, length and number of baffles installed.

The spacing between baffles, and the number of baffles installed, was determined by the culvert gradients (i.e. more baffles were installed in shorter intervals where gradients were steeper) (Figure 1; Table 1).

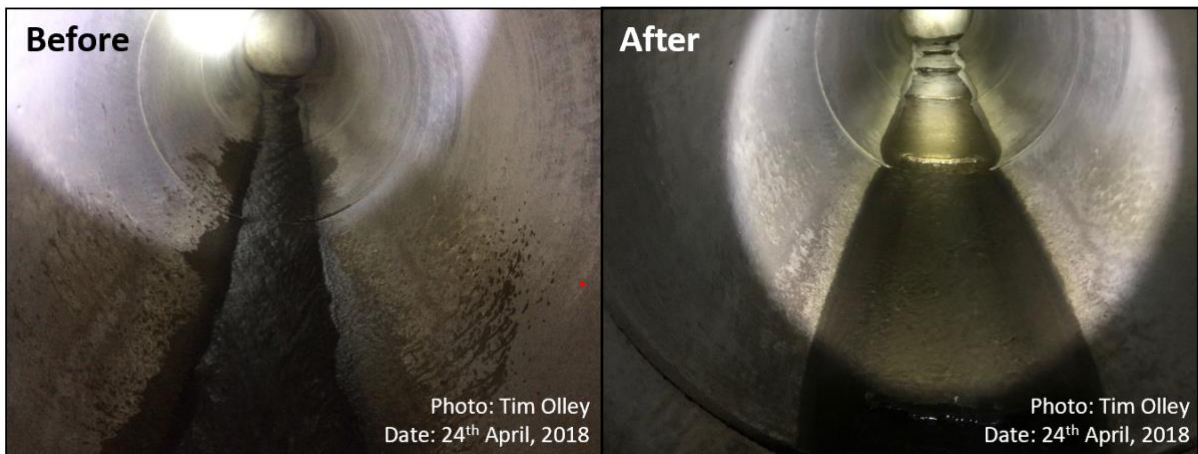
It was considered that high barrel water velocities due to the steepness of culvert gradients were impeding successful upstream passage of fish.

Figure 2. Lower section of the Reservoir Creek culvert before and after Flexi-baffle installation.

In April 2018, a total of 79 Flexi-baffles (ATS Environmental Ltd) were secured within the culvert to reduce water velocities and create resting pools within the culvert (Figure 2). Flexi-baffles are a type of flexible baffle made of a recycled polymer and were fabricated to suit the culvert. All 79 baffles were 600 mm wide and 100 mm high with 50 mm slits and 45-degree cuts at both ends to allow fish passage around the baffle (Figure 2 and 3). The baffles were attached to the concrete culvert floor with stainless-steel sleeve anchors (M6.5 x 40 mm) and stainless-steel penny washers (32 mm). In the metal section of the culvert we used stainless steel tek-screws (14G x 25 mm) with stainless-steel penny washers (32mm).

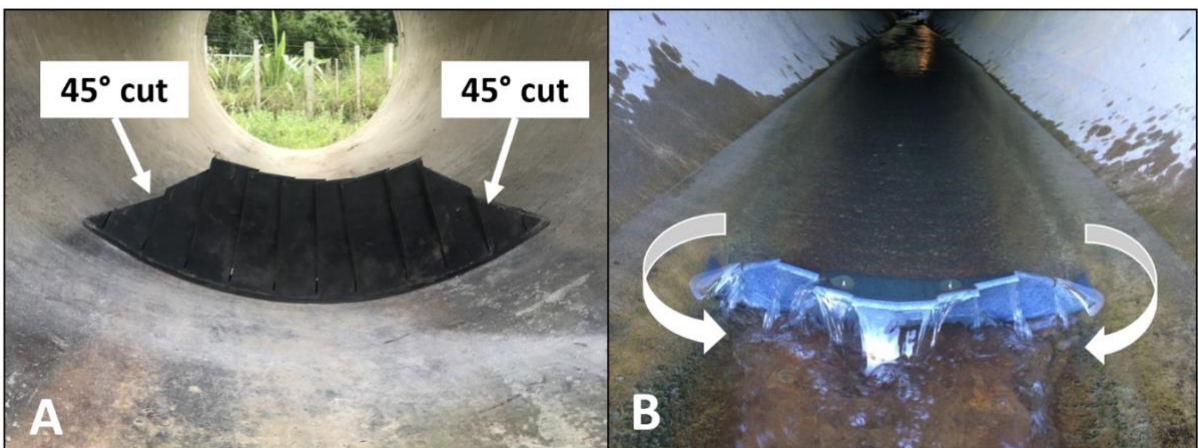
Figure 3. Each baffle is cut at 45° on either side (A) to allow water to spill around the baffle (B) enabling fish passage, even at low flows (Note: photographs are not from Reservoir Creek culvert).

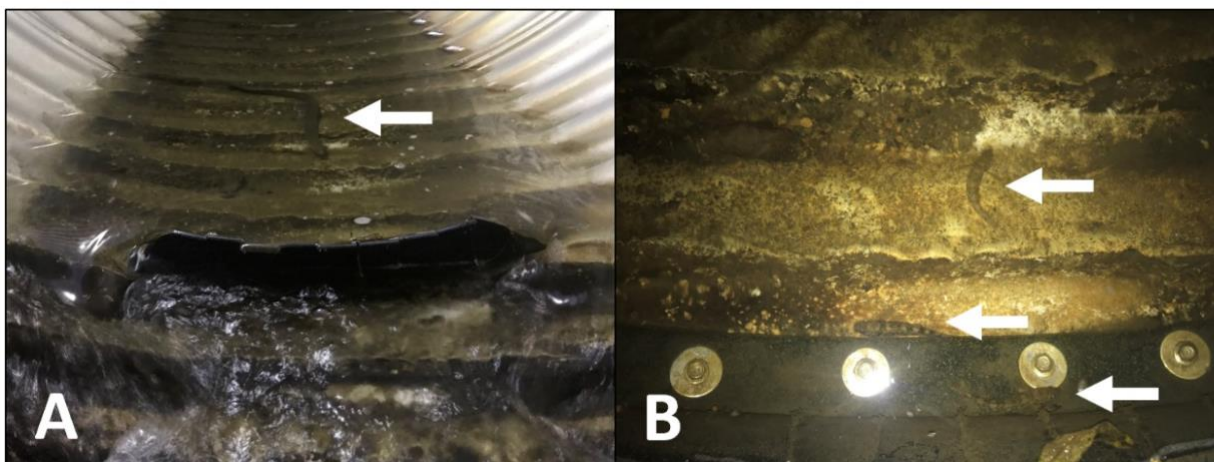
Several inspections within the culvert barrel have been carried out to assess baffle durability. During those inspections, anecdotal observations showed fish in pools between baffles and swimming upstream around the 45-degree cuts in the baffles and may be using baffles as refuge (Figure 6).

Figure 6. Photo A shows an eel in a pool upstream of a Flexi-baffle. Photo B shows three common bully in a pool upstream of a baffle near the top of the culvert.
