Fish-Passage Field Findings

Jan 12, 2020

Lessons Learnt 03: Floating ramp with mussel-rope

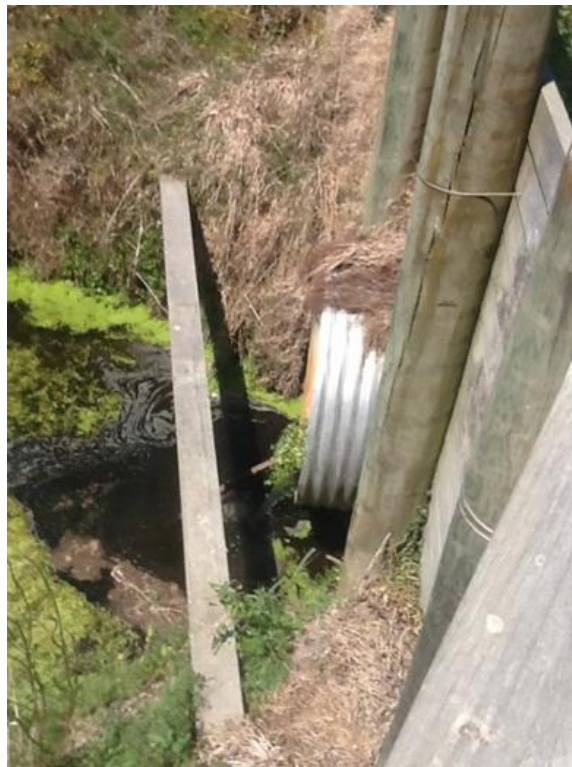
The culvert is located approximately 12 km from the coast, with a diameter of 800mm, and is perched by 800mm with an undercut of 480mm.

The culvert was identified as likely causing a barrier to fish migration (Figure 1).

Flow exited the culvert into a deep plunge-pool, presenting with significant scouring of the bed material.

The culvert barrel had no bed material, indicating that it was possibly a velocity barrier.

Figure 1: Outlet prior to remediation

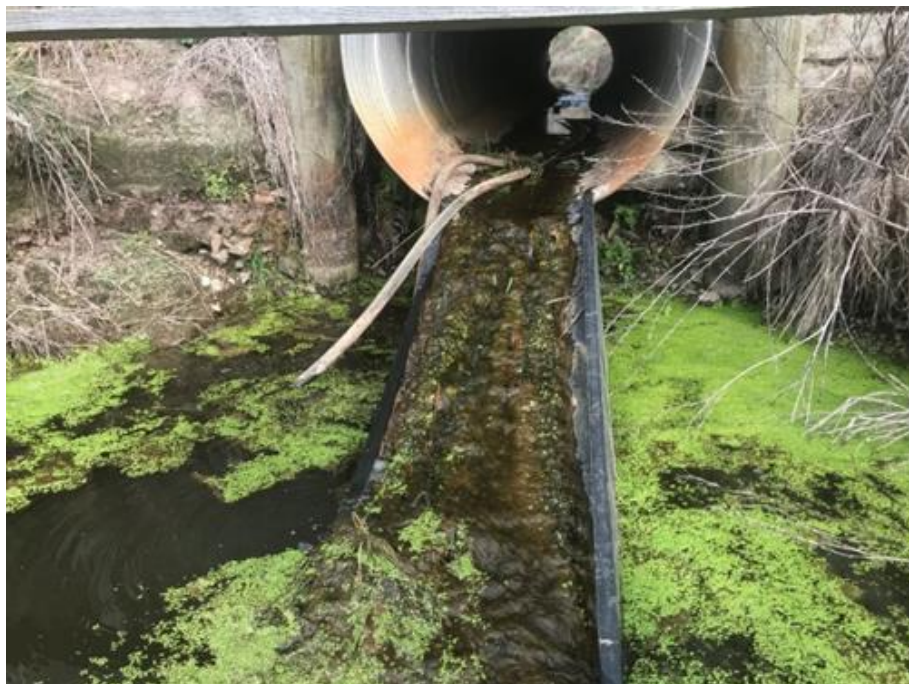
Figure 2: Outlet post-remediation

- The flexible baffles noticeably increased the depth and complexity of the flow through the culvert.
- After a period (following the study), the ramp appeared to have reduced scour at the outlet, resulting in a redeposition of bed-material thereby infilling the plunge-pool and reducing the gradient of the ramp.

A 2.4-meter floating ramp (ATS-Environmental) at approximately 30° gradient at time of installation.

The ramp was attached to the culvert with a flexible rubber coupling.

The ramp has a 15° “V” and a smooth surface i.e., not Miradrain® dimples as featured in the NZ Fish Passage Guidelines.

8 lengths of mussel-rope were fitted down the ramp in 2 bundles of 4 strands instead of using Miradrain®.

The mussel-rope passes over a 100mm high flexible v-baffle with 45° cut ends, fitted 300mm up from the outlet of the culvert (Figure 2).

There further three 100mm x 600mm flexible baffles were fitted evenly spaced throughout the pipe to create rest pools and complex flows with low velocity zones.

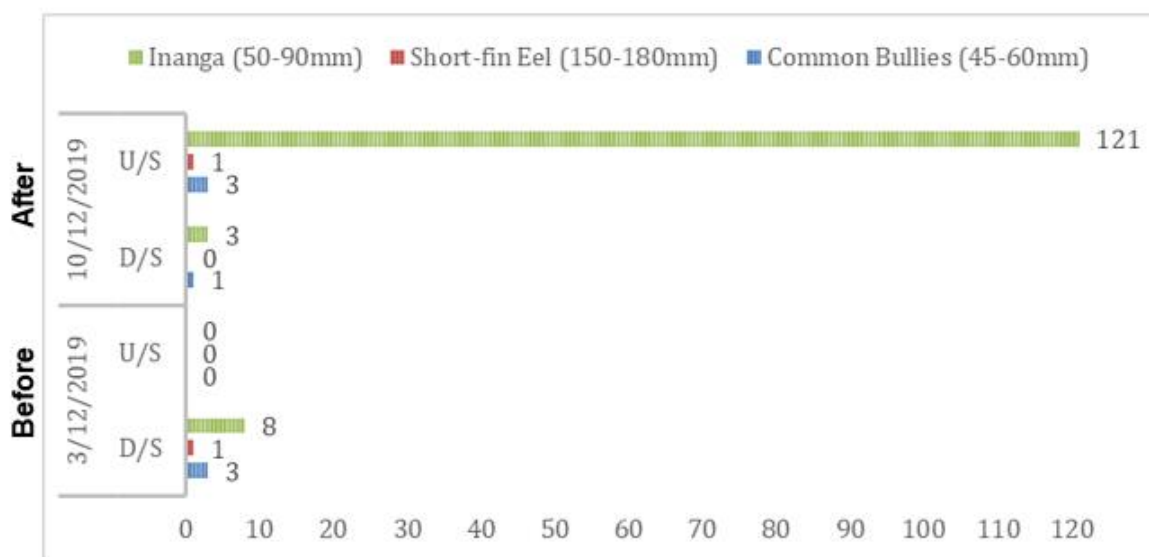
Pre-remediation survey found a total of 12 fish downstream of the barrier (8 inanga, 1 short-fin eel, 3 common bully), with no fish captured upstream of the culvert (Figure 3.).

After remediation, a total of 4 fish (1 common bully, 3 inanga) were captured downstream, while 125 fish were captured upstream of the culvert (3 common bully, 1 short-fin eel, 121 inanga) (Figure 3.).

Figure 3: Data results
