# Fish-Passage Field Findings

April, 2019

## Lessons Learnt 01: Retrofit of an existing fish pass with flexible baffles to improve fish passage for all species.

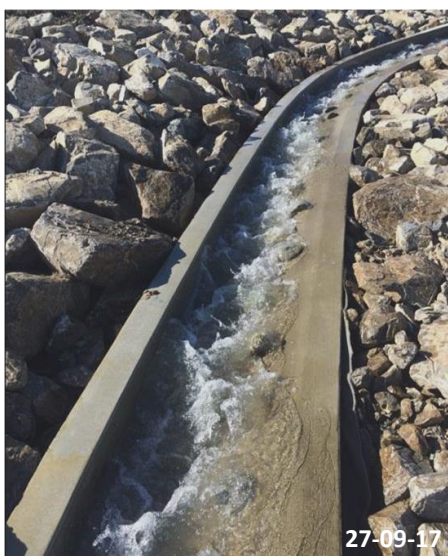
The original fish pass design, installed in June 2017, considered fish passage by providing a 107 m long by 500 mm wide by 200 mm deep, angled fish “ladder” over a dam wall in Saxton Creek, Nelson, NZ (Figure 1). Rocks were embedded into the concrete ladder with the aim of slowing the flow and introducing nature-like flows.

- High velocity water in long sections of the fish pass was likely a barrier to fish movement.
- There was a lack of low velocity areas for fish to rest as they migrate upstream.
- No fish were observed using the fish pass.

Figure 1. Angular fish pass with rocks

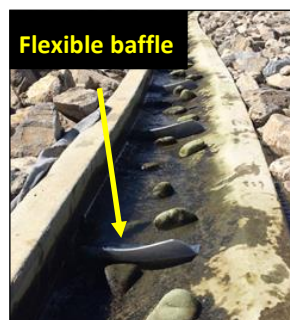
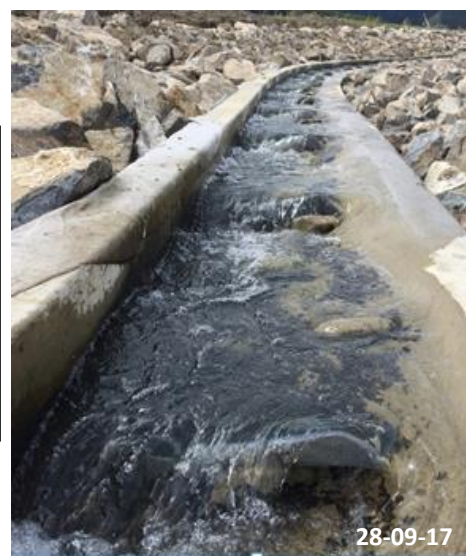
Figure 2. Angular fish pass with rocks and flexible baffles

Eighty flexible baffles were installed to further reduce water velocity and break up the flow (Figure 2 & 3). These baffles were fabricated to fit the triangular design of the fish pass and offset 50 mm from the deep edge of the channel to allow for passage in low flows. Baffles were 450 mm wide and 100 mm high with 45-degree cuts at both ends to allow fish passage around the baffle (Figure 2 & 3).

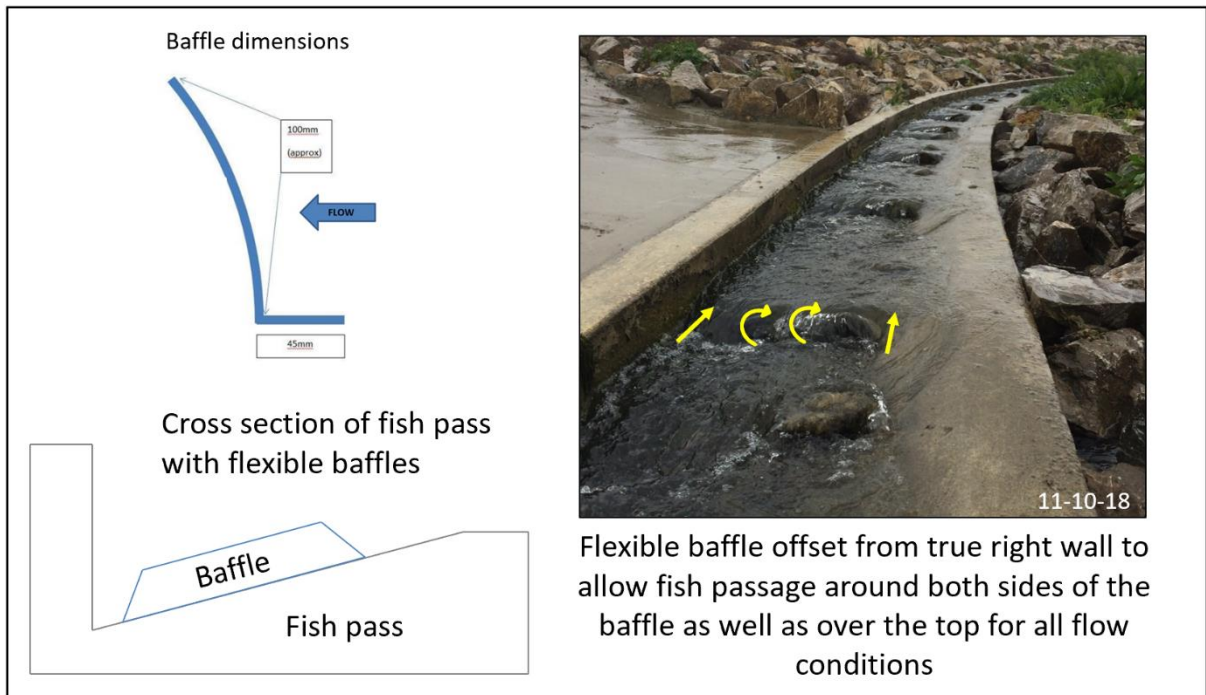
**Figure 3. Flexible baffle dimensions and positions within the fish pass**

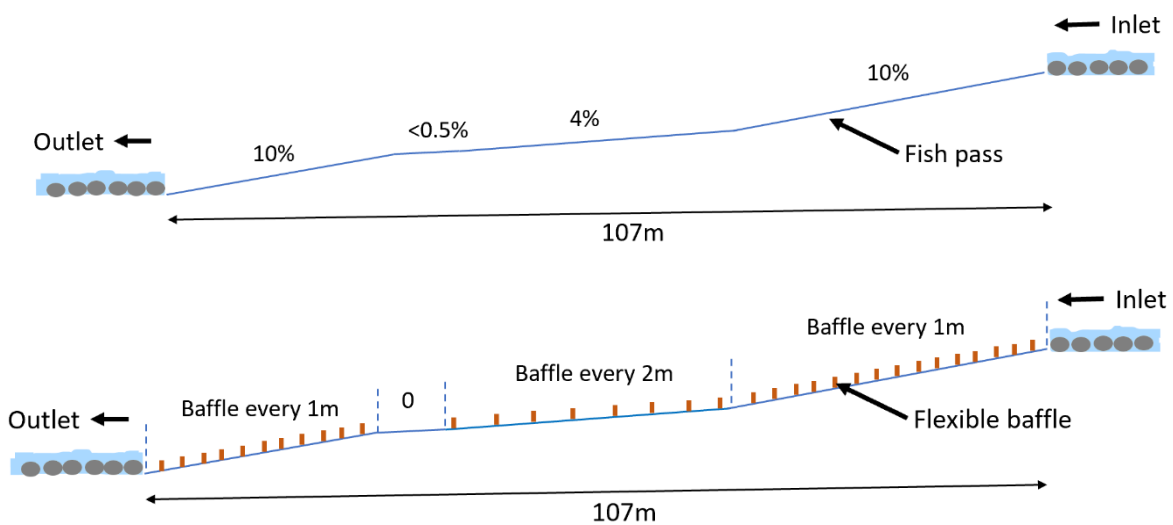
**Figure 4. Cross sections of the Saxton Creek fish pass showing the changes in gradient (top) and the spacings between baffles (bottom)**

Baffle spacing’s were determined based on the grade of concrete (Figure 4). Grades throughout the fish pass ranged from <0.5% to 10%. Baffles were installed within the fish pass except where grades were <0.5%. Water velocities through the low-grade section (<0.5%) were not considered a barrier to fish. Baffle placement was limited to areas where rock was not embedded. As a result, spacings between baffles did vary.

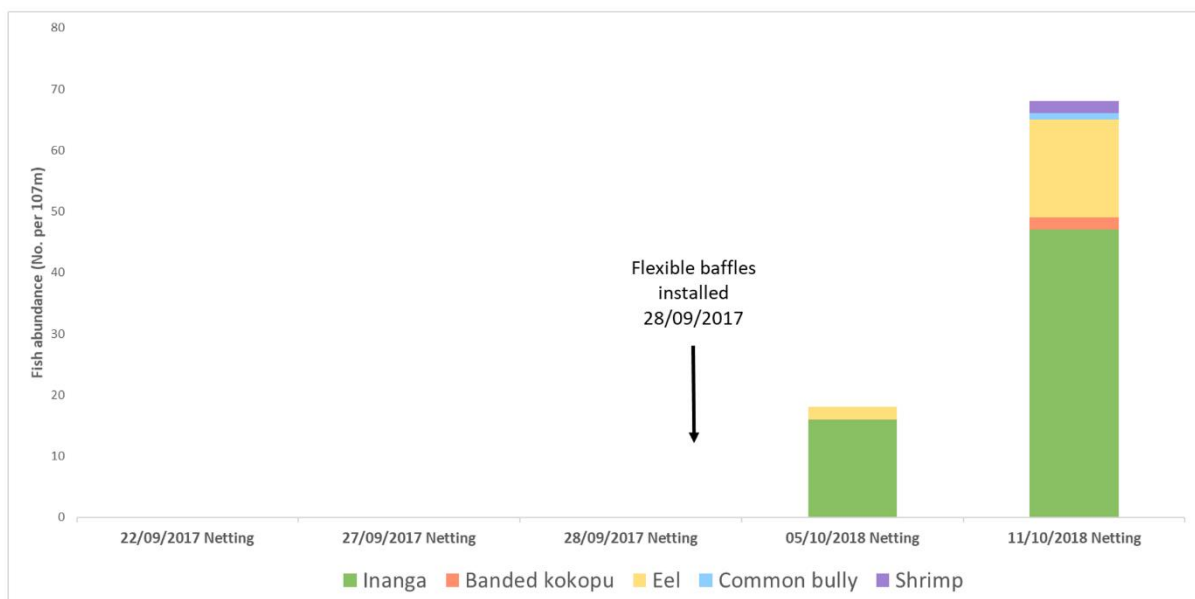
In the days prior to the retrofit with baffles, the fish pass was dewatered three times. As the water was drained, nets at the outlet were used to capture any fish retreating out of the pass. The residual pools were then searched with hand nets. On all three occasions no fish were found within the fish pass (Graph 1). It was possible that fish were not migrating at the time of these assessments, however this seems unlikely given inanga (*Galaxias maculatus*) were observed in Saxton Creek below the fish pass, indicating that fish were migrating.

Two surveys using hand nets were conducted one-year post-baffle installation over the entire fish pass. This involved “guiding” fish to a downstream stop net repeatedly over short distances e.g. between two baffles at a time. Fish species were noted and released downstream of the survey point. A total of 18 fish were caught on the 5<sup>th</sup> of October 2018, including 16 inanga and two common bullies (Graph 1). 68 fish were captured during hand netting on the 11<sup>th</sup> of October 2018, including 47 inanga, 16 unidentified eels, two banded kokopu, and one common bully (Graph 1) (Figure 5). Overall, fish species and abundance were noticeably different to pre-baffle inspection within the fish pass (Graph 1).

**Graph 1. Results of fish abundance monitoring in the Saxton Creek fish pass before and after baffle retrofit.**

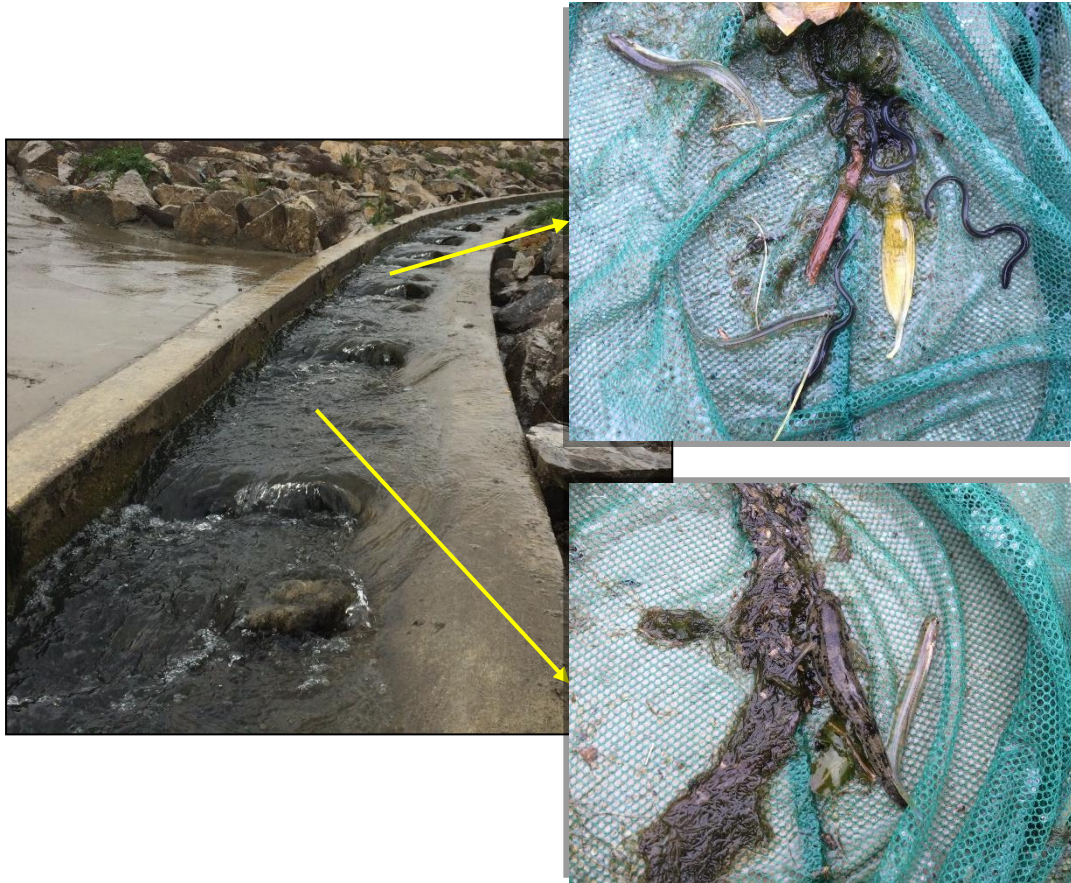
Survey results following the installation of flexible baffles suggest that several fish species are using the fish pass to migrate upstream. Juvenile eels, banded kokopu (*Galaxias fasciatus*) and inanga have been found within, and upstream of the fish pass. Inanga occupied the fish pass the day after the retrofitting of baffles. The presence of “poorer” swimming fish species like inanga within, and above the structure, suggests the fish pass will likely provide passage for fish species of all swimming capabilities.

**Figure 5. Fish caught during a hand net survey of the Saxton Creek fish pass on the 11-10-18. Species pictured above include inanga, eels and a common bully.**

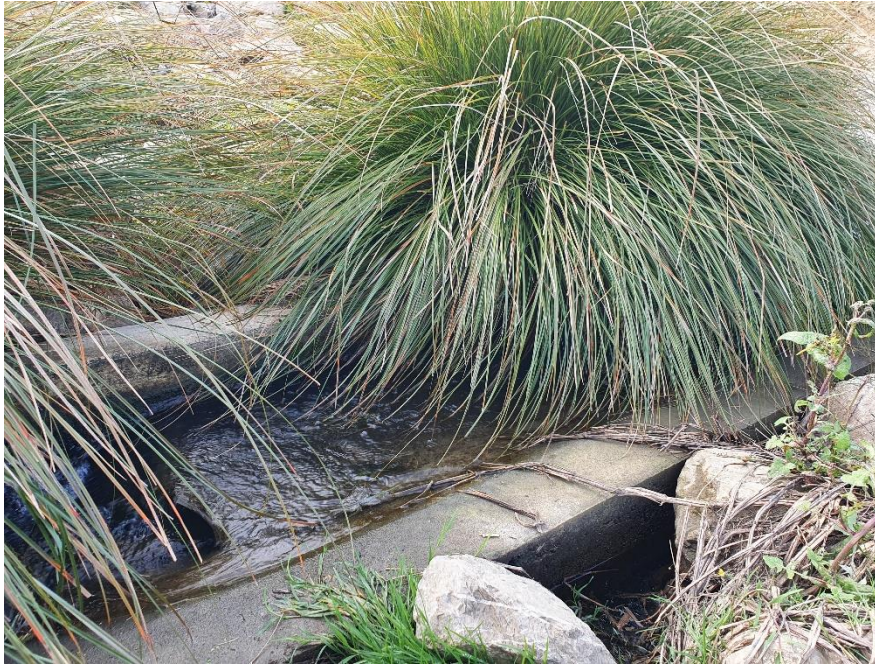
**Figure 6. Carex secta planted adjacent to the fish pass.**

- The true left-hand side of the fish pass should be higher to ensure all water remains in the pass and nothing spills over the edge.
- Weed growth within the fish pass became an issue and at times excessive water was pushed off the structure. Consideration should be given to vegetation and shading with any fish pass designs. In this instance, *Carex secta* was planted on the true right-hand side of the fish pass to provide shading and therefore attempt to inhibit weed growth (Figure 6).
